SLOPE STABILITY AND GEOLOGY
OF THE BALDWIN HILLS,
LOS ANGELES COUNTY, CALIFORNIA

1982

CALIFORNIA DEPARTMENT OF CONSERVATION
DIVISION OF MINES AND GEOLOGY

SPECIAL REPORT 152

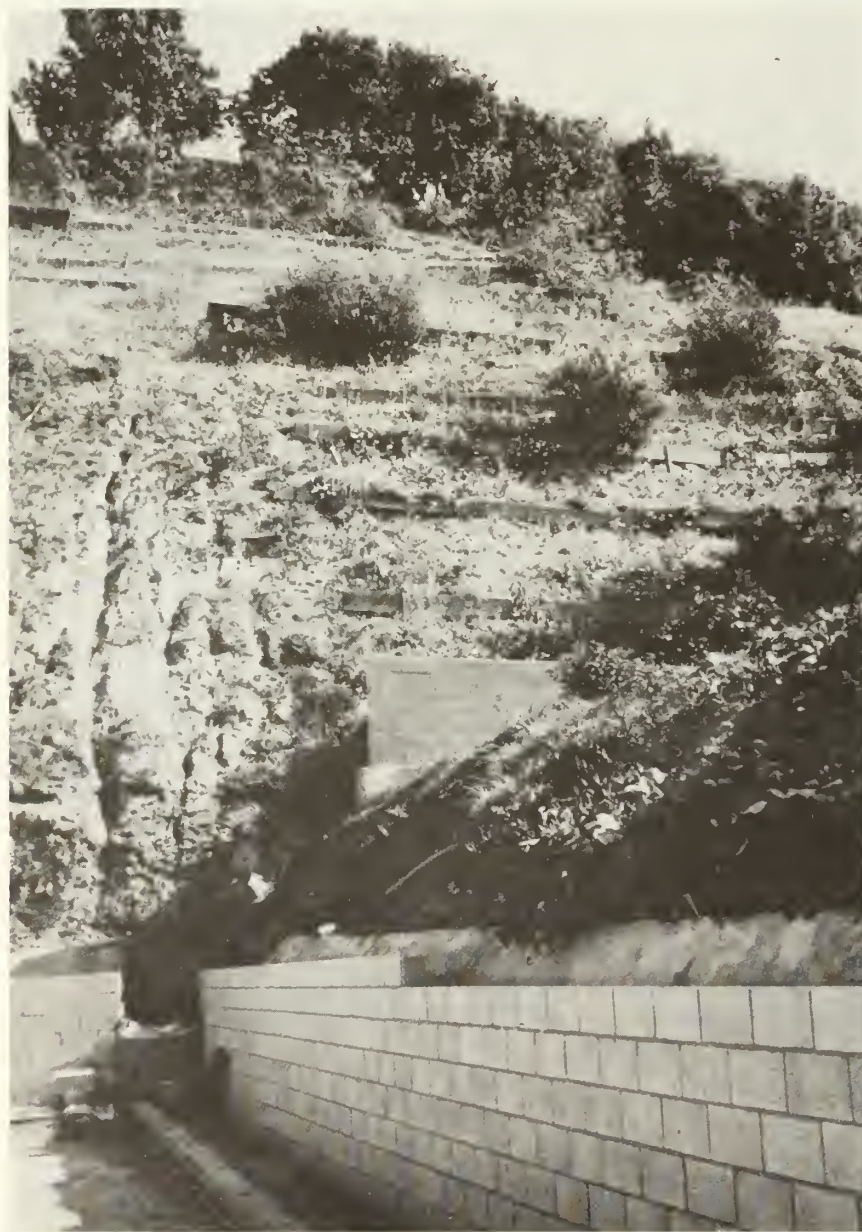
Photo 38. View east on east side of Cloverdale Avenue. Upper part of photo shows expedient board and pipe revetment structure (A) on steep cut slope. Structure has temporarily prevented erosion damage to slope, as has occurred on bare slope to the north. Lower part of photo shows retaining walls and accompanying structures (B) that drain water to street. (Slope segment 2-0, Sub-area 2.)

Construction of revetment systems. A revetment system is generally a less effective but also a less costly method of slope stabilization which is generally applied as a temporary repair measure for damaged slopes (item 2 on Figures 15 and 17). Damaged slopes can be superficially repaired and stabilized with many types of revetment structures, such as board and pipe structures (batter boards) (Photos 38 and 39), railroad ties, poured-concrete walls, concrete-block walls, and other landscape devices. Figure 17 illustrates the method commonly used. For board and pipe systems, pipes are driven vertically into firm material, generally bedrock, to a depth sufficient to anchor them. Railroad ties or redwood planks are then placed so that they are supported by the pipes. Suitable materials are then backfilled against the planks and compacted to at least 90% of maximum

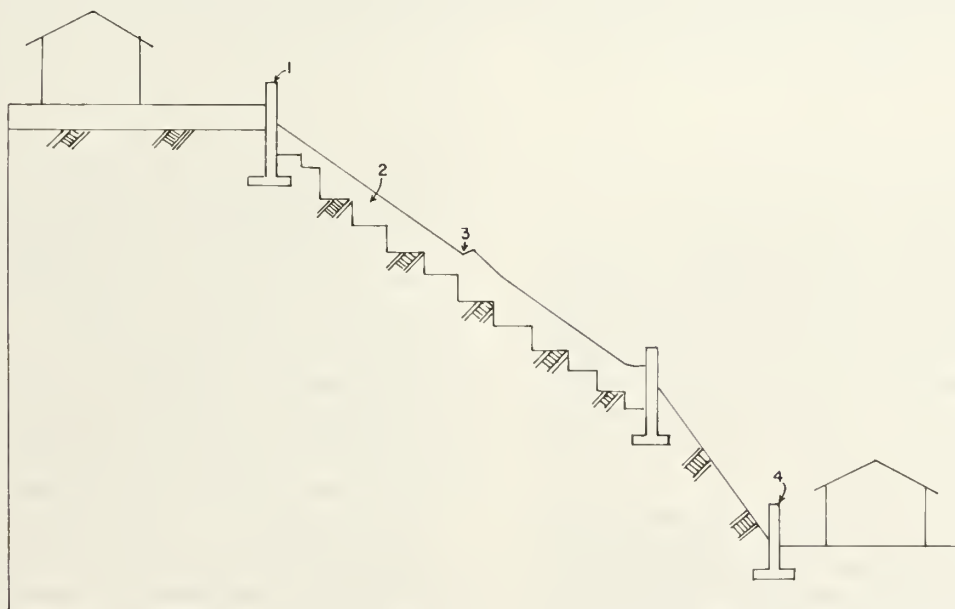
Figure 18. Diagrammatic cross section illustrating alternative remedial measures utilizing a revetment system and engineered fill to stabilize slopes in residential areas of the Baldwin Hills: (1) Properly designed retaining wall and drainage devices (such as granular backfill and drain pipe behind the wall and weep holes in the wall). (2) Loose soil and slide debris are removed, stabilization fill is then properly keyed and benched into firm bedrock as shown, and adequate subdrains should be provided. For steep slopes, soil-cement fill may be desirable. (3) Gunite or concrete bench drains that divert water to discharge outlet are constructed. (4) Retaining wall with adequate freeboard and a drainage device to prevent downhill earth movement and water/mud damage to property are constructed. (Not drawn to scale.)

dry density. Ideally, the retaining boards or planks should have adequate freeboard (height above the finished surface of backfill) so that the structure can also function as a debris or slough wall. Subdrains within the backfill should also be considered in order to reduce hydrostatic pressure and seepage erosion. Photo 38 illustrates a less sophisticated system of board and pipe revetment structures, whereas Photo 39 illustrates a more sophisticated system. Figure 18 illustrates the use of a combination of engineered fill and revetment structures to stabilize a slope.

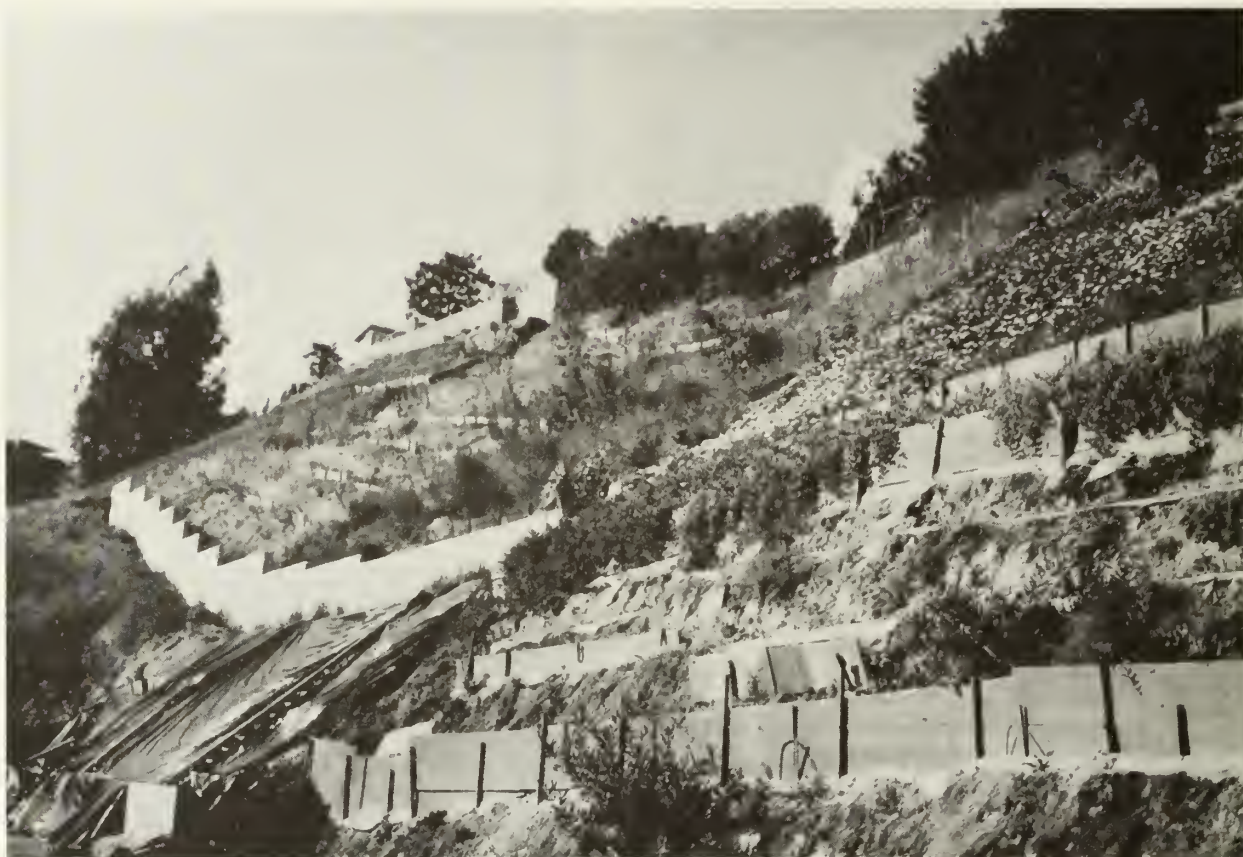
Photo 39. View northwest in February 1981 of slope in back of apartment buildings on Don Tomoso Drive showing board and pipe revetment structures constructed after 1978 rains to protect slopes. Note mid-slope retaining wall on property to left. Note also expedient use of plastic sheeting together with other slope stabilization measures. (Locality 74, Sub-area 3, Plate 1 and Table 3c.)

Concrete block and poured concrete walls also have been constructed on slopes, particularly at property lines (located generally at the middle of slopes) to prevent potential debris flows originating on the up-slope properties to cause damage to the down-slope properties (Photo 39).

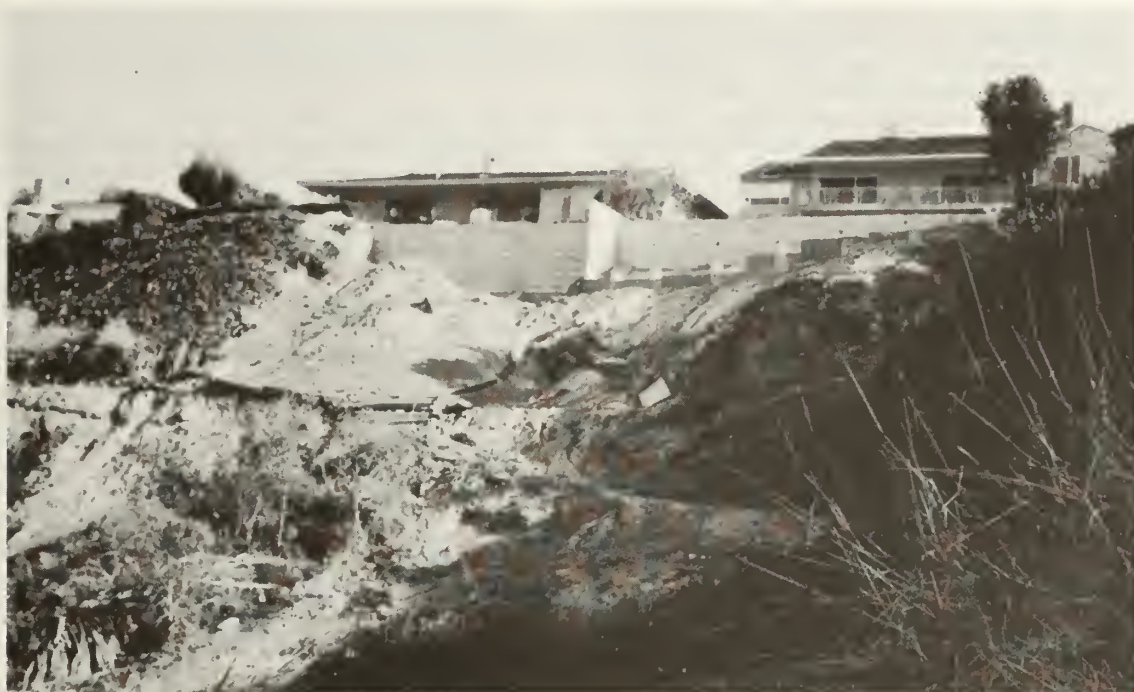
Phata 40. Retaining wall under construction in February 1981 at top of slope on south side of Stocker Street, just east of Valley Ridge Drive. Houses are on Kenway Avenue. Wall is designed to protect two properties at top of swole that has been a source of debris slides and flaws. Out af view slightly to the west is a strang retaining wall built during construction of adjoining house on Kenway Avenue in late 1951 or early 1952. (Locality 81, Sub-area 3, Plate 1 and Table 3c.)

In addition to supporting weak fills at tops of slopes, retaining walls can be constructed at bottoms of slopes to support new engineered fills. As a sole slope stabilization measure, retaining walls can also be used to support slopes underlain by weak soils or bedrock weakened by faulting or weathering. Photo 40 shows a retaining wall under construction.

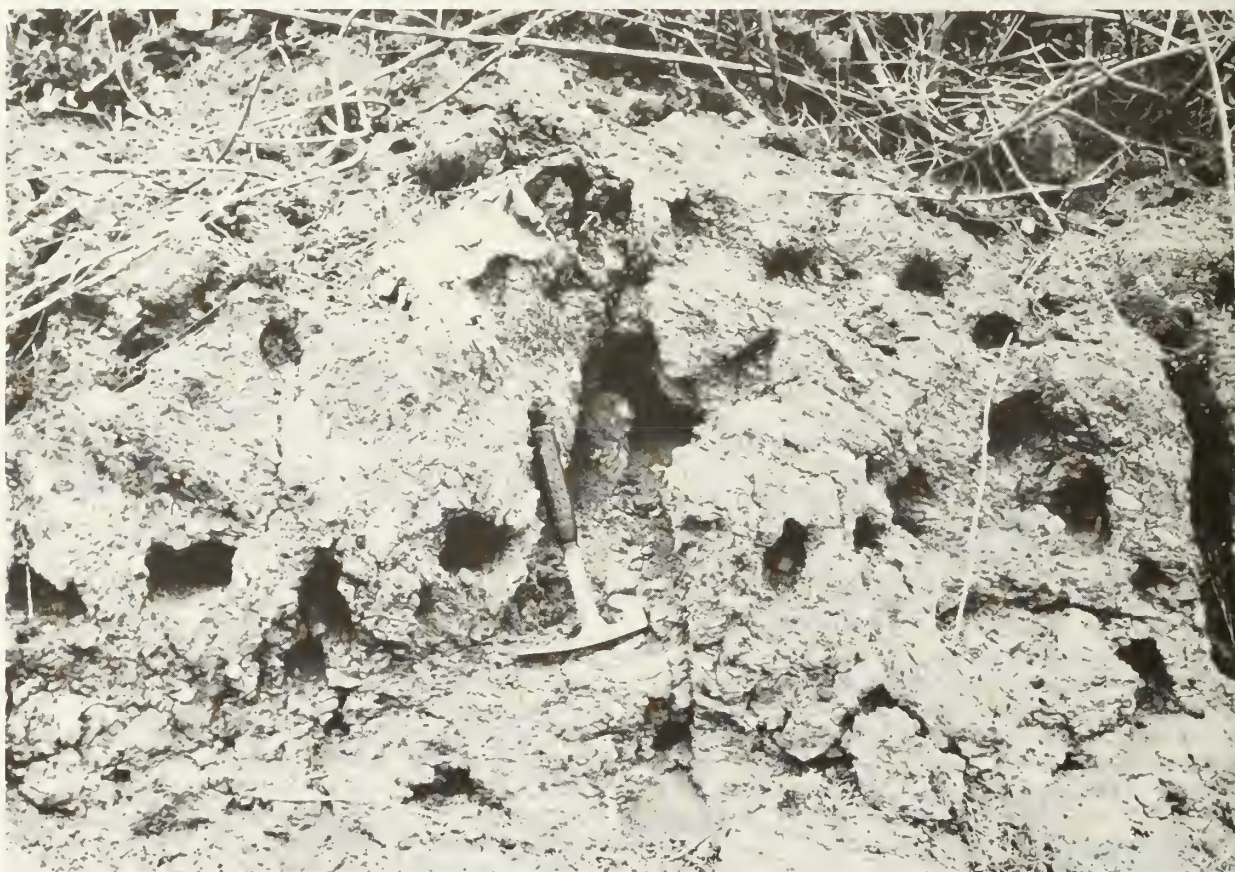
Gopher holes are common in the Baldwin Hills, particularly in natural slopes (Photos 41 - 43). These holes and their accompanying network of underground tunnels facilitate water penetration into the ground, promote erosion, and decrease the shearing strength of the soil. In addition, the activities of gophers adversely affect needed plant growth on slopes. It is recommended strongly, therefore, that rodent abatement programs be implemented in the Baldwin Hills to control the activities of these animals. To be effective, abatement programs should not only include developed areas but adjoining undeveloped areas as well. If gophers are abated only in a developed area, new gophers from adjoining undeveloped areas that are not abated will soon renew the digging and tunneling problems in the abated area. In addition, gopher abatement programs should be followed up with grouting programs to fill-in abandoned burrows and restrengthen weakened slopes in the developed areas.

Photo 41. Gopher holes in rubbly soil. Note how holes tend to join and open up along fractures. This is a common cause of "piping" (Photo 33). Burrowing rodents should be trapped or gassed but not flushed out with water. The use of water is not apt to succeed and may start erosion through piping. In Qb and Qc units, rodent holes commonly extend well into the weathered bedrock underlying the soil. (Sub-area 5.)

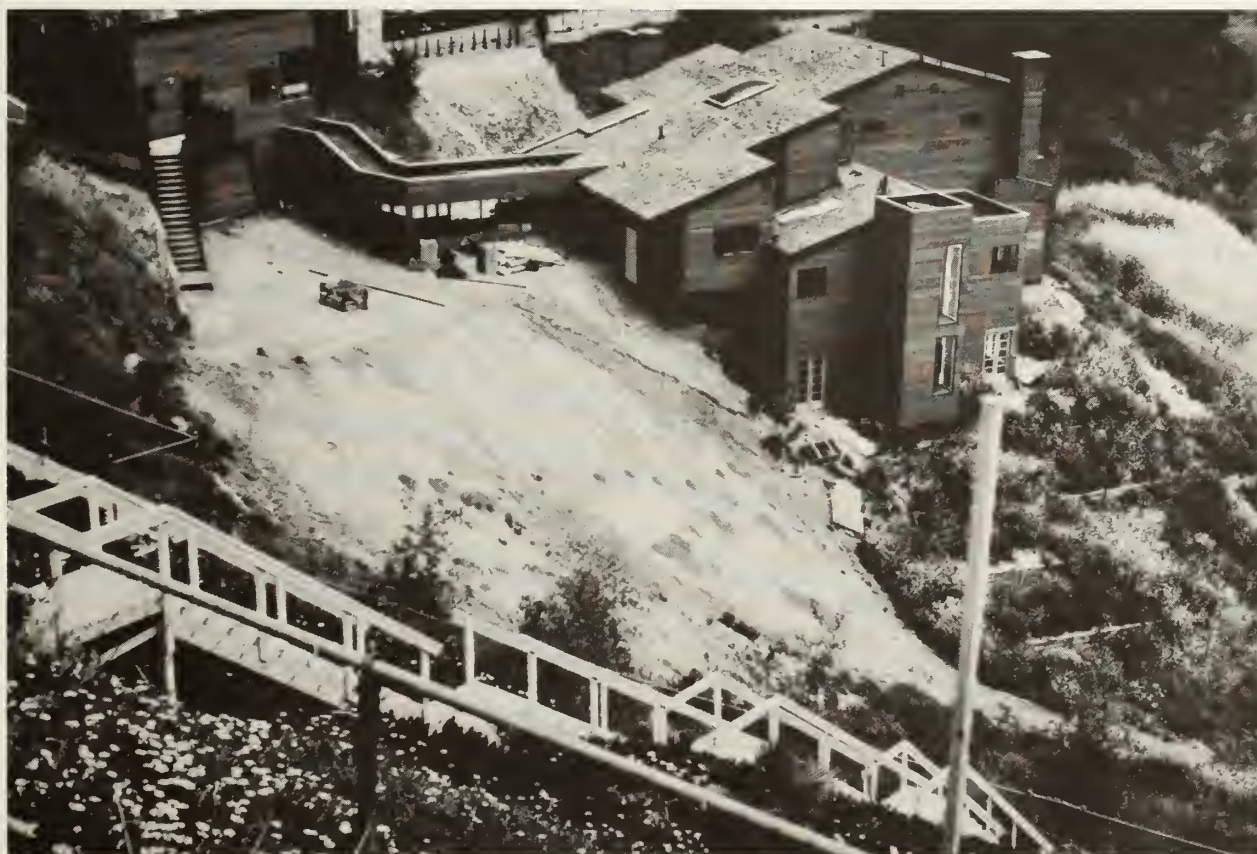
Photo 42. View shows gopher holes that have already appeared in a newly graded bedrock slope for a new house on El Mirador Drive, Los Angeles City. The house was not yet completed when this photo was taken. (Locality 47, Sub-area 2, Plate 1 and Table 2b.)

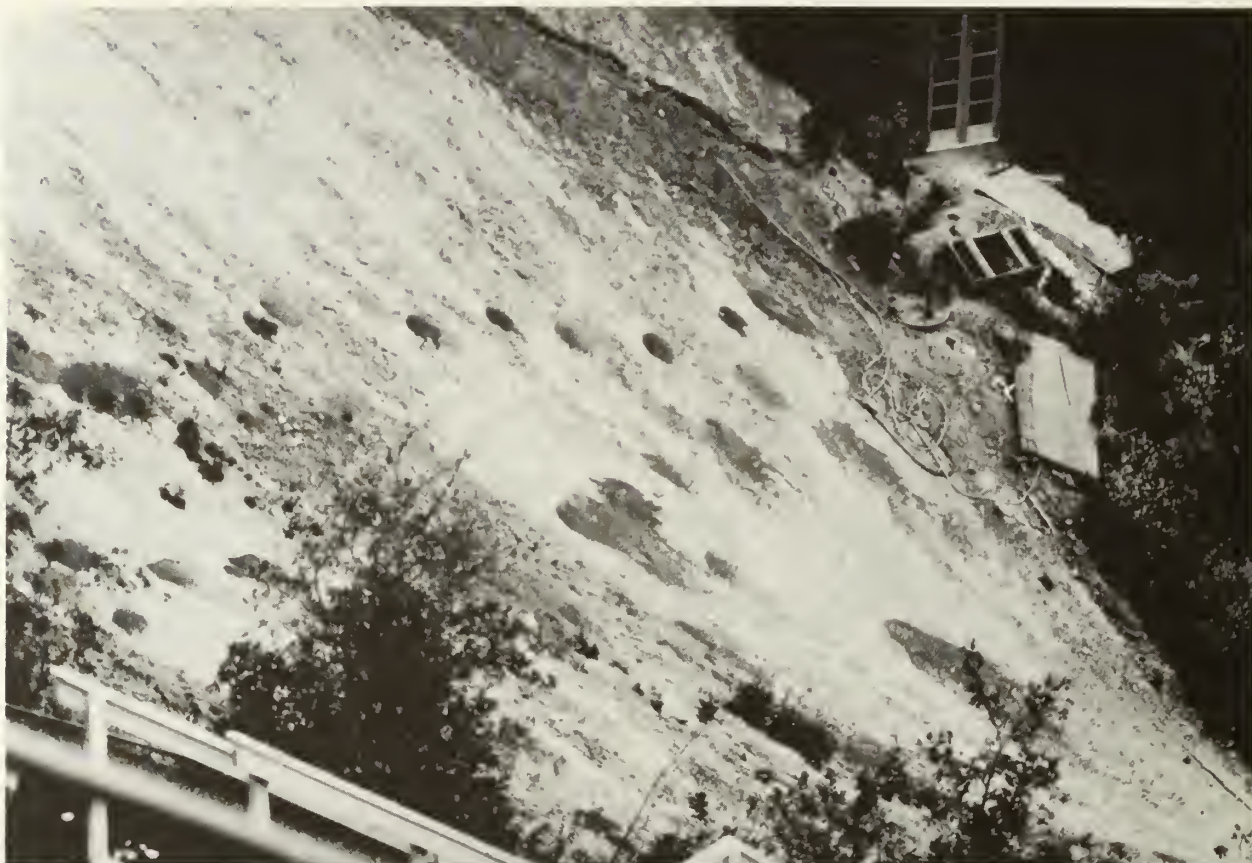
Photo 43. Closeup view of gopher holes shown in Photo 42. The scene emphasizes the need to control gophers in order to maintain slope stability.

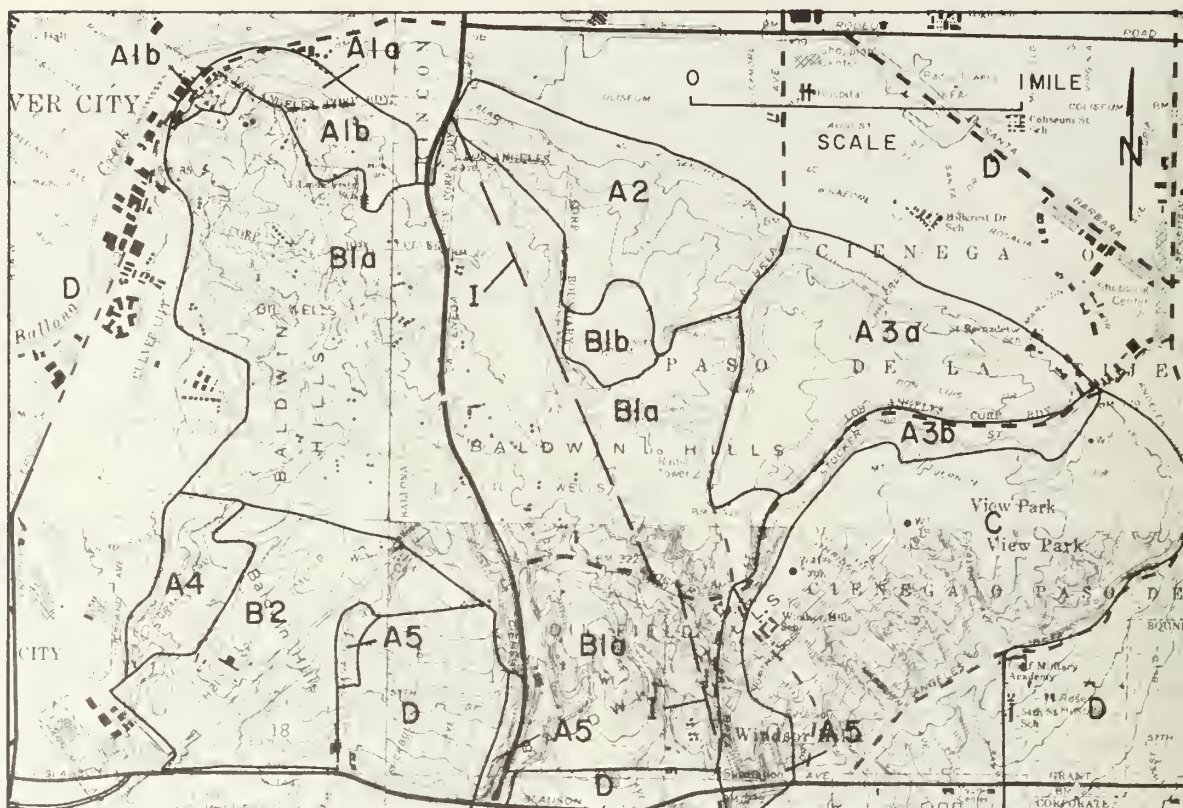
Figure 19 shows that Sub-areas 1 - 4, the principal areas of the Baldwin Hills damaged by rainfall in the past, constitute the principal areas for potential future damage. In contrast, Sub-area 5 consists mostly of nearly flat ground or very gentle slopes that have not had serious problems in the past and do not seem to be in danger of widespread serious failures in the future. Sub-area 6, which now constitutes an oil field, is tentatively planned to be developed as a Los Angeles County regional park when the oil field is depleted. If all or part of the area is developed residentially or industrially, however, it must be graded according to the modern grading code of the County of Los Angeles. Sub-areas 1 - 4 were developed when local grading codes were in their infancy.

Figure 19. Generalized classification of the Baldwin Hills for propensity to landslides and erosion. See accompanying explanation for details.
